SUB-SLAB FLUSHING & RECOVERY OF NO. 2 FUEL OIL

HUDSON VALLEY, NEW YORK
AUGUST 2020

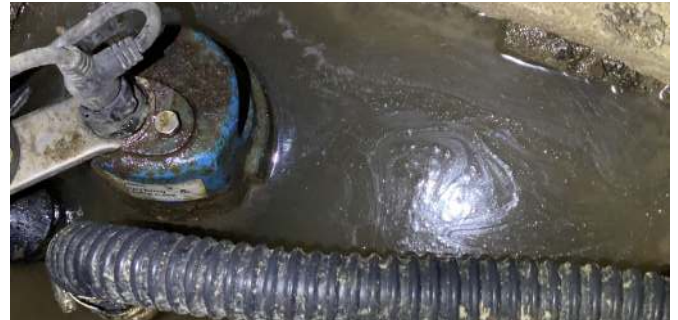
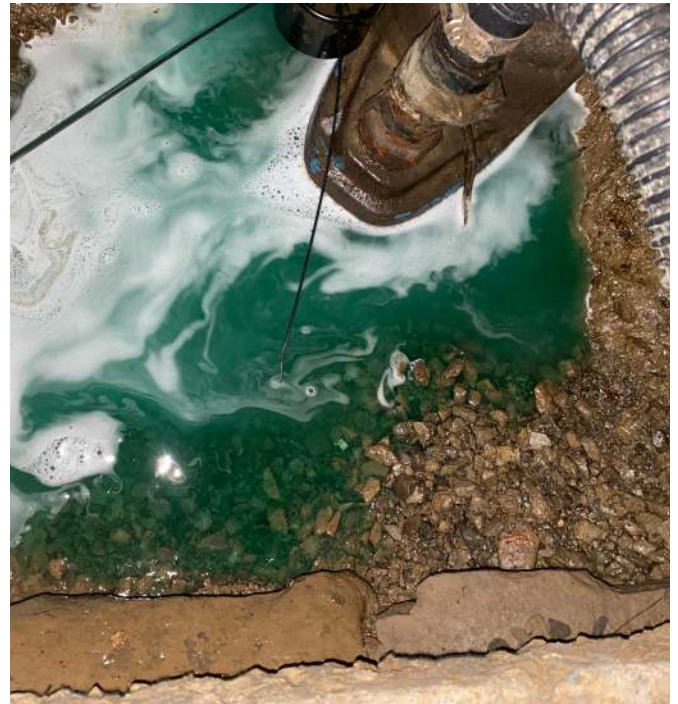
A number two fuel oil release occurred from an exterior tank of a residence, contaminating the soils surrounding the tank as well as under the adjacent basement floor slab. The excavatable soil was removed for offsite disposal and a remediation plan was put in place for the remaining areas. Through a series of holes and PVC injection points, a 3% solution of EcoGreen was flushed underneath the slab and all fluids were directed toward a collection point in the basement sump for recovery and disposal. Approximately 2,000 gallons of EcoGreen solution were injected under the basement floor slab over the course of two flushes. Efficacy screening and soil samples were collected after the remediation, confirming that the EcoGreen treatment had been successful in both the remediation and in vapor suppression. In total, over 8,000 gallons of the oily water mixture were collected and transported offsite to be properly disposed of.
